Mold Screen  
Inspection Report

Inspection Date & Time: 10/30/2005 9:00 AM

Client's Name: The Smith Residence

Inspected Address: 100 Main St  
Williamsport, PA 17701

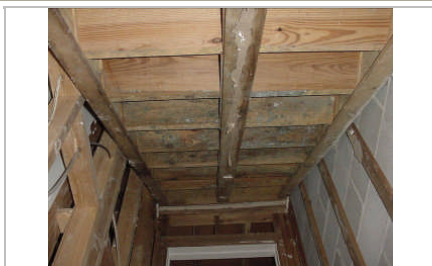
Suspected Mold: Yes 40 sq. ft. Musty Odor: Yes

Cause:  Plumbing  Roof Leak  Condensation  Other ditch outside of wall

Mold growth on wood stairwell due to excessive humidity in basement

unless ditch outside of foundation is corrected water intrusion will continue to cause mold growth

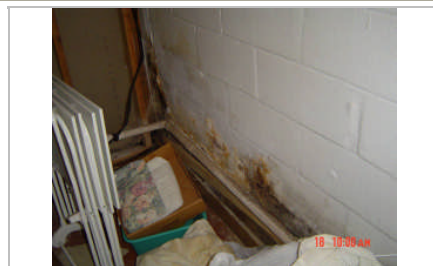
Mold growth in North corner interior where outside ditch is located

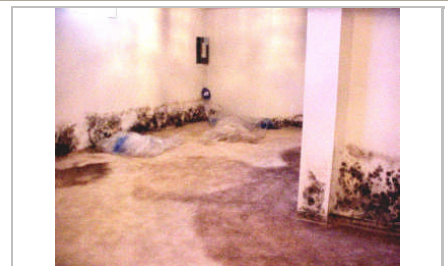
see pictures of grading problems

Fix ditch or else this will happen!

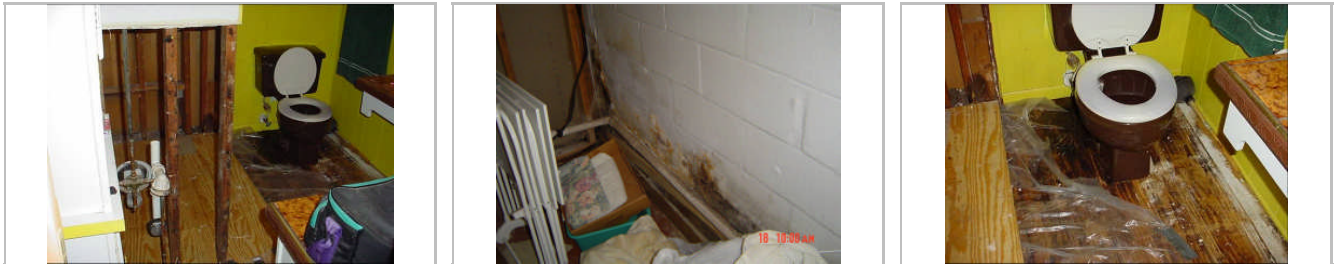
Area: around toilet

Moisture Stains : Yes Active: Yes Moisture meter Reading: 31

Suspected Mold: Yes 8 sq. ft. Musty Odor: Yes

**Concern:**  
plumbing leaks around toilet

**Recommended Action:**  
Fix plumbing leaks and dry wood
